FINAL REPORT  
RICHARDSON FLATS TAILINGS  
SUMMIT COUNTY, UTAH  
TDD #T08-9204-015 and #T08-9210-050  
PAN EUT0039SBA and EUT0039SDA

U.S. Environmental Protection Agency  
Region VIII  
Waste Management Division  
Mike Zimmerman, On-Scene Coordinator

Scott Keen  
Ecology and Environment, Inc.  
Technical Assistance Team

DATE SUBMITTED: February 19, 1993

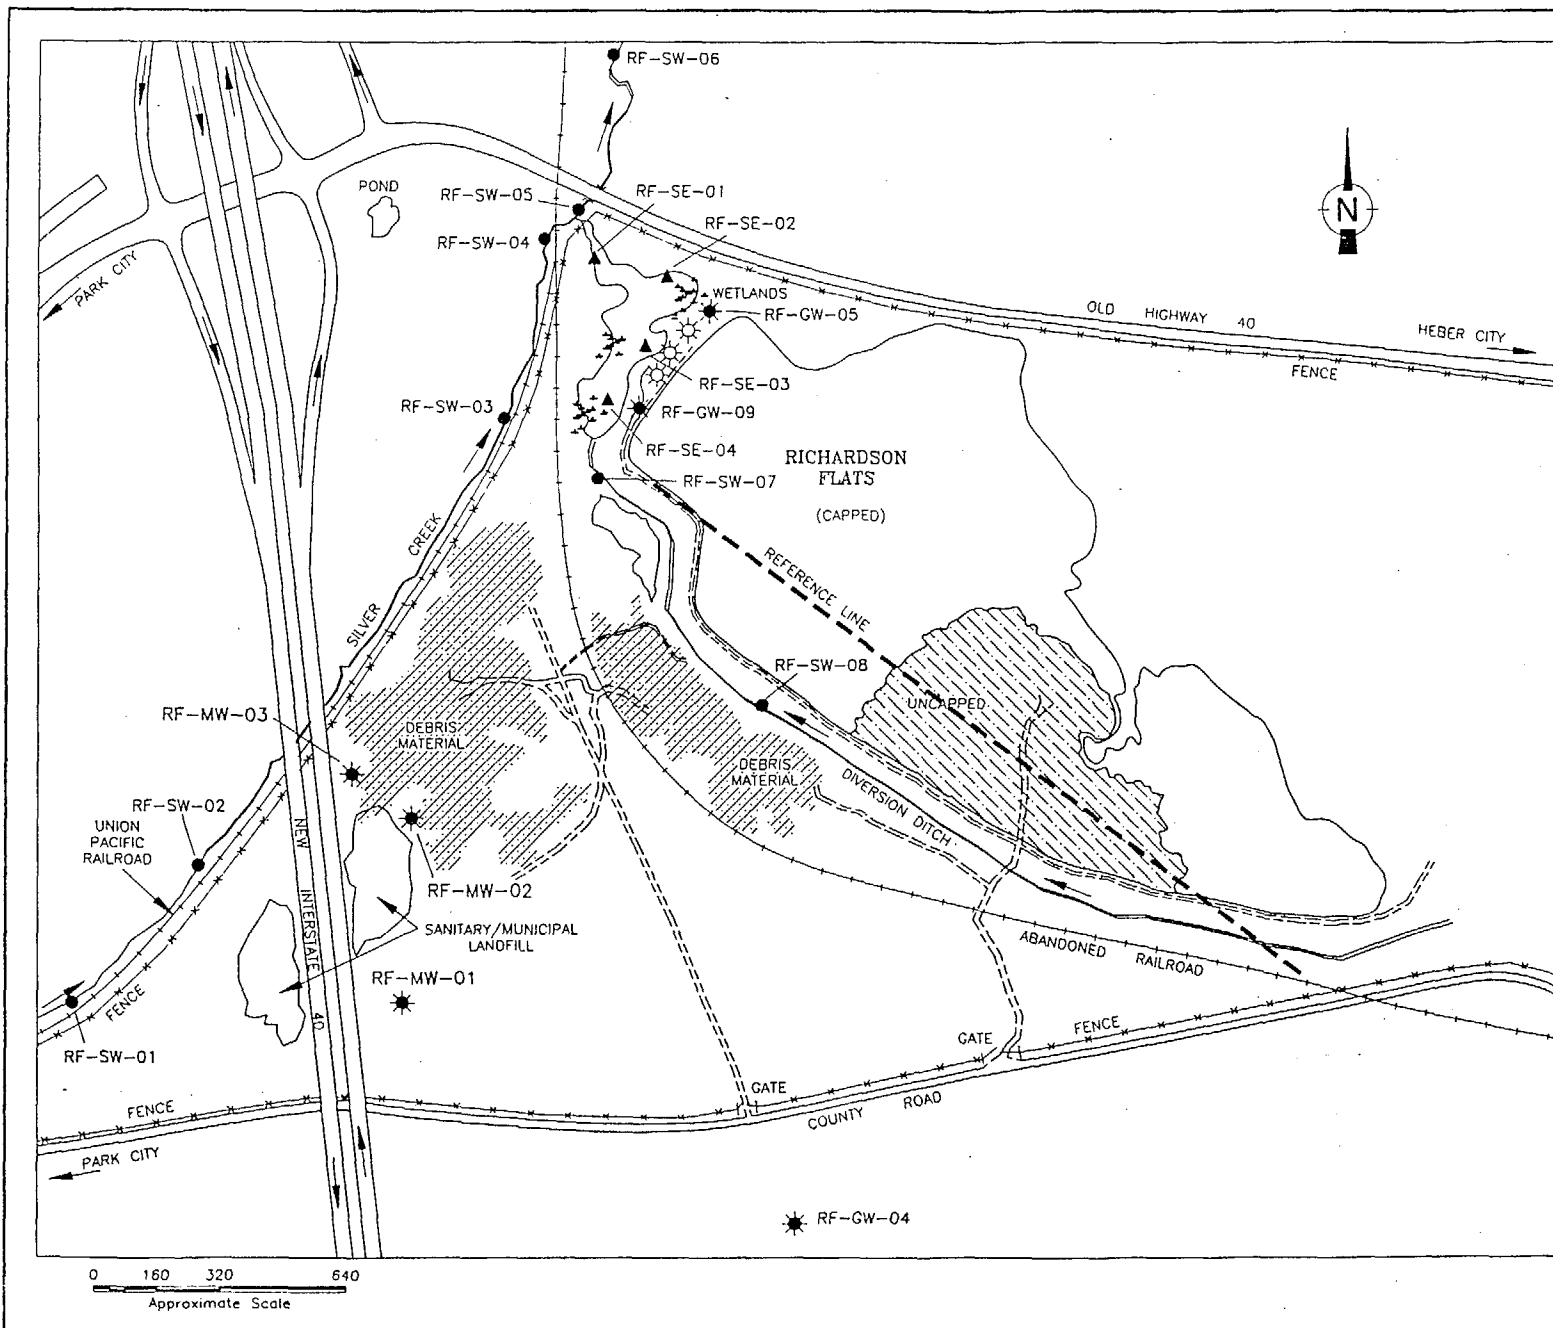
FIG. 1

Surface water samples collected for assessment of the tailings area are shown on Figure 1. These eight sample numbers are RF-SW-01 through RF-SW-08. Inorganic analytical results for surface water samples are presented in Table 3. Within Silver Creek samples RF-SW-01 through RF-SW-04 are considered upgradient of the tailings area and samples RF-SW-05 and RF-SW-06 are downgradient. In comparing upgradient sample results with downgradient sample results very few significant differences are noted. Lead increases by a factor of 5.7 in sample RF-SW-05 when compared to the average lead concentration of the four upgradient samples. In sample RF-SW-06 arsenic increases by a factor of 2.1 and silver increases by a factor of 4.2 when compared to the average concentration of the four upgradient samples.

One upgradient and two downgradient monitoring wells (Figure 1) were sampled during the week of August 4, 1992. Results of inorganic analyses are presented in Table 6. Sample RF-GW-04 is from the upgradient well; samples RF-GW-05 and RF-GW-09 are from two wells at the base of the tailings dam.

Figure 1 shows a "wetlands" area between the base of the tailings dam and Silver Creek. Within this area four sediment samples were collected. Results of inorganic analyses of these samples is presented in Table 7 along with the normal ranges of elemental concentrations in soils of the western United States.

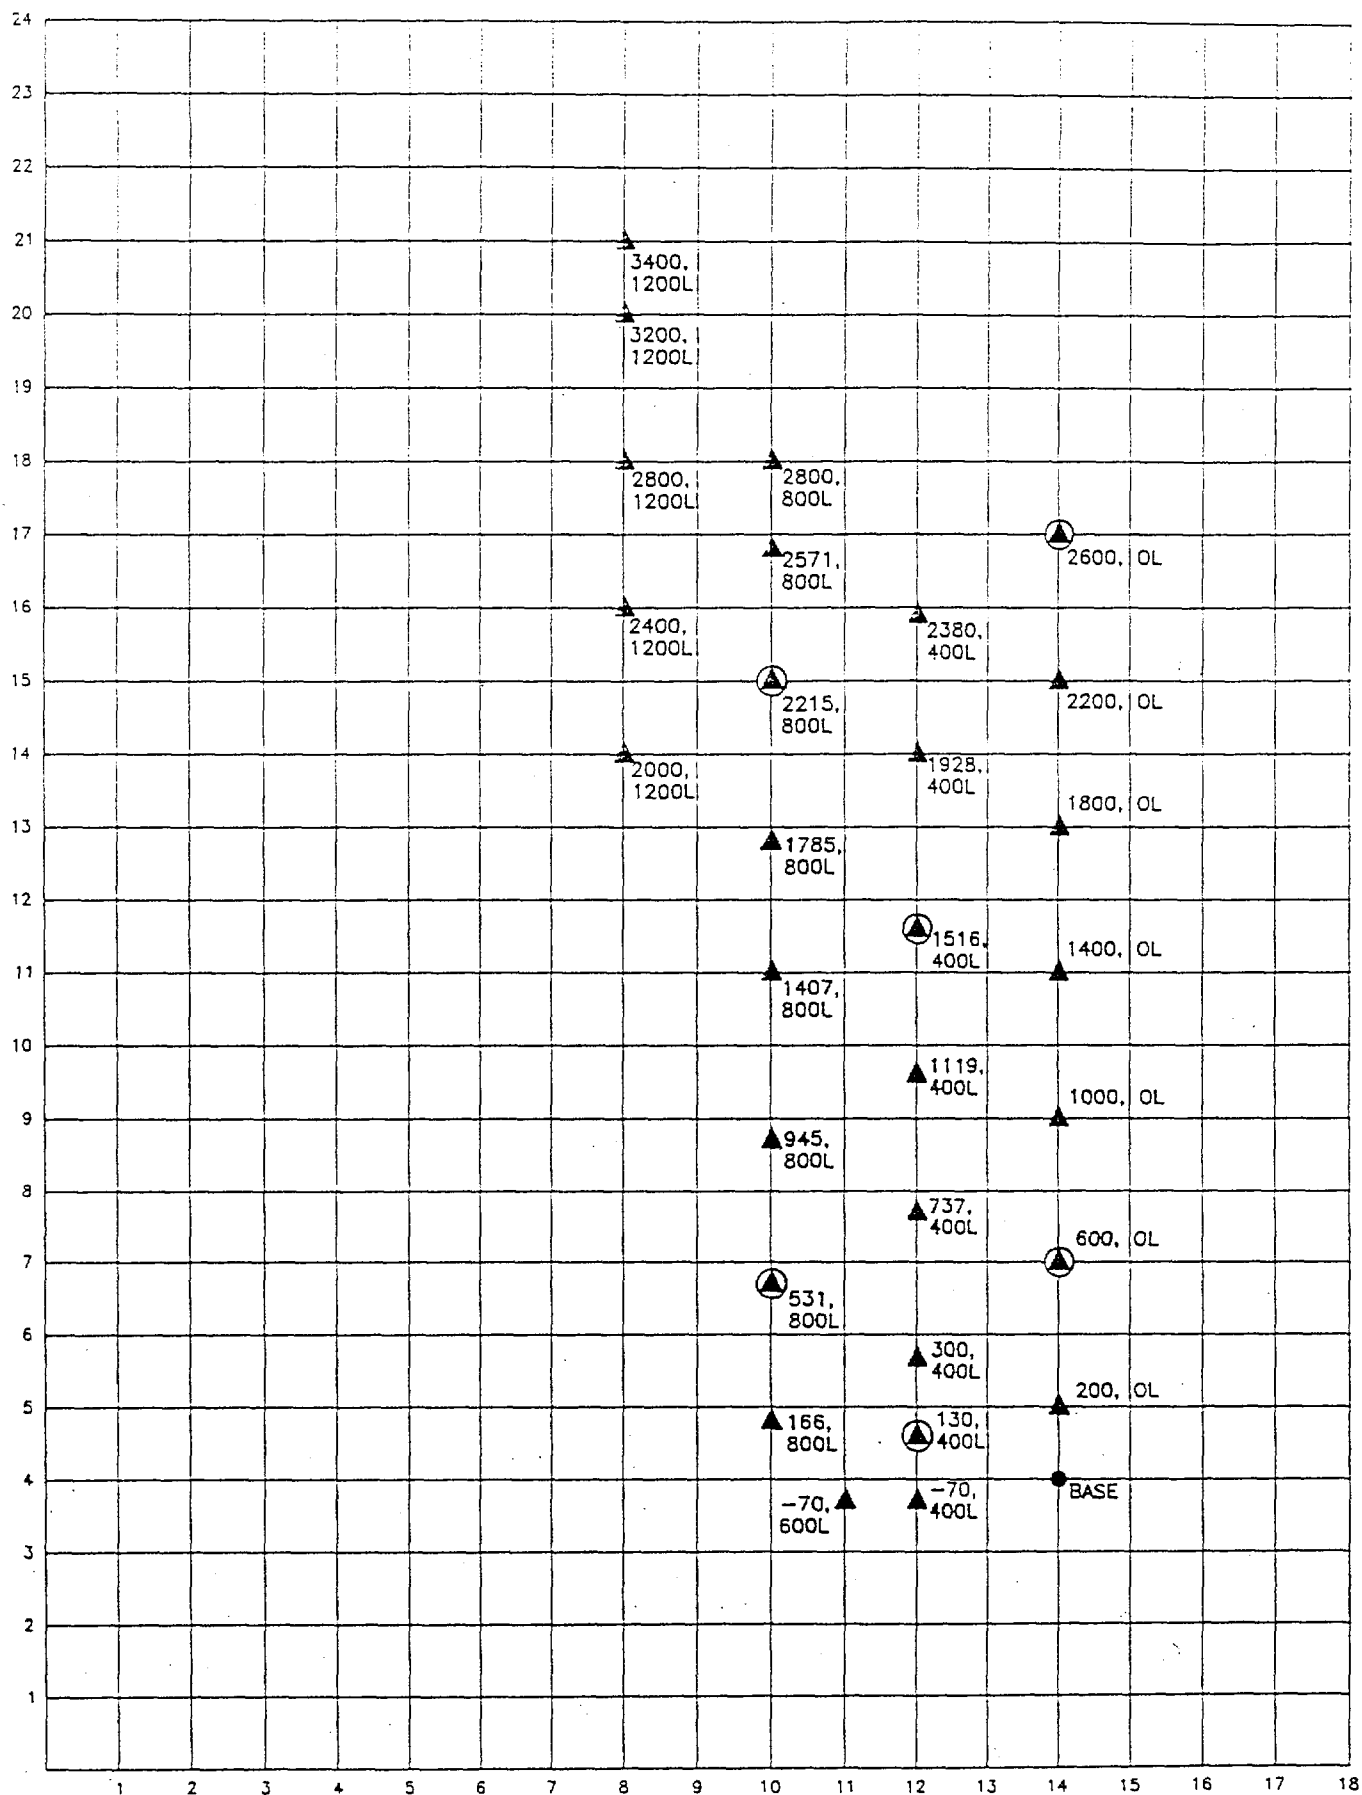
Depth of cover was determined at 29 locations over the tailings area. These locations are depicted on Figure 2. Locations were determined by first establishing a reference line in an approximate direction of northwest to southeast through the tailings area (Figure 1). This reference line includes and is a continuation of a straight portion of the tailings containment structure as shown in Figure 1. Points were marked along this reference line at 200 or 400 foot intervals. At 2800 feet from the base point a second reference line was established in a perpendicular direction to the first reference line. This second reference line extended in an approximate direction from southwest to northeast. For the purpose of sampling or soil cover measurements, all locations within the tailings area were identified relative to these two reference lines. For example, a sample location identified as 1900, 800L would be 1900 feet from the base point (using the first reference line) and 800 feet to the left (northeast) using the second reference line.

The grid pattern shown in Figure 2 represent much of the entire tailings area. Of the 29 points on this grid only 1 point had no cover soil and no salt grass present. Nine of the 29 points (approximately 30 percent) had no cover soil present. At the 20 points where cover soil was present, the cover soil was 6 inches thick or less at 6 points and greater than 6 inches in thickness at 14 points.

Figure 2 shows the location of six soil samples collected on August 6, 1992. Each of these samples, except sample RF-SO-3, was taken from soil that was added by UPCM as cover to the site. Table 2 contains analytical results for these samples and the normal ranges for these elements in soils of the western United States. Sample RF-SO-3 was collected within an area covered by salt grass. As discussed, where salt grass is currently established soil cover has not been added by UPCM. This soil sample is more likely to be representative of tailings material.

UPCM has expressed intentions of adding soil cover to that small portion of the site which currently has no soil cover or where salt grass is not established. When this is completed, the tailings area will have adequate cover to prevent an immediate threat of excessive dust. Much of the existing soil cover, however, is sparse (less than six inches in thickness); and much of the area is covered with a salt grass that may disappear as the site becomes drier. Dusty conditions could recur in the future if proper soil cover over the entire tailings area is not applied.
